Cape Cod Canal
Massachusetts

**SAGAMORE
HIGHWAY BRIDGE**

1976 Condition Report

CONTRACT NO. DACW 33-76-C-0005

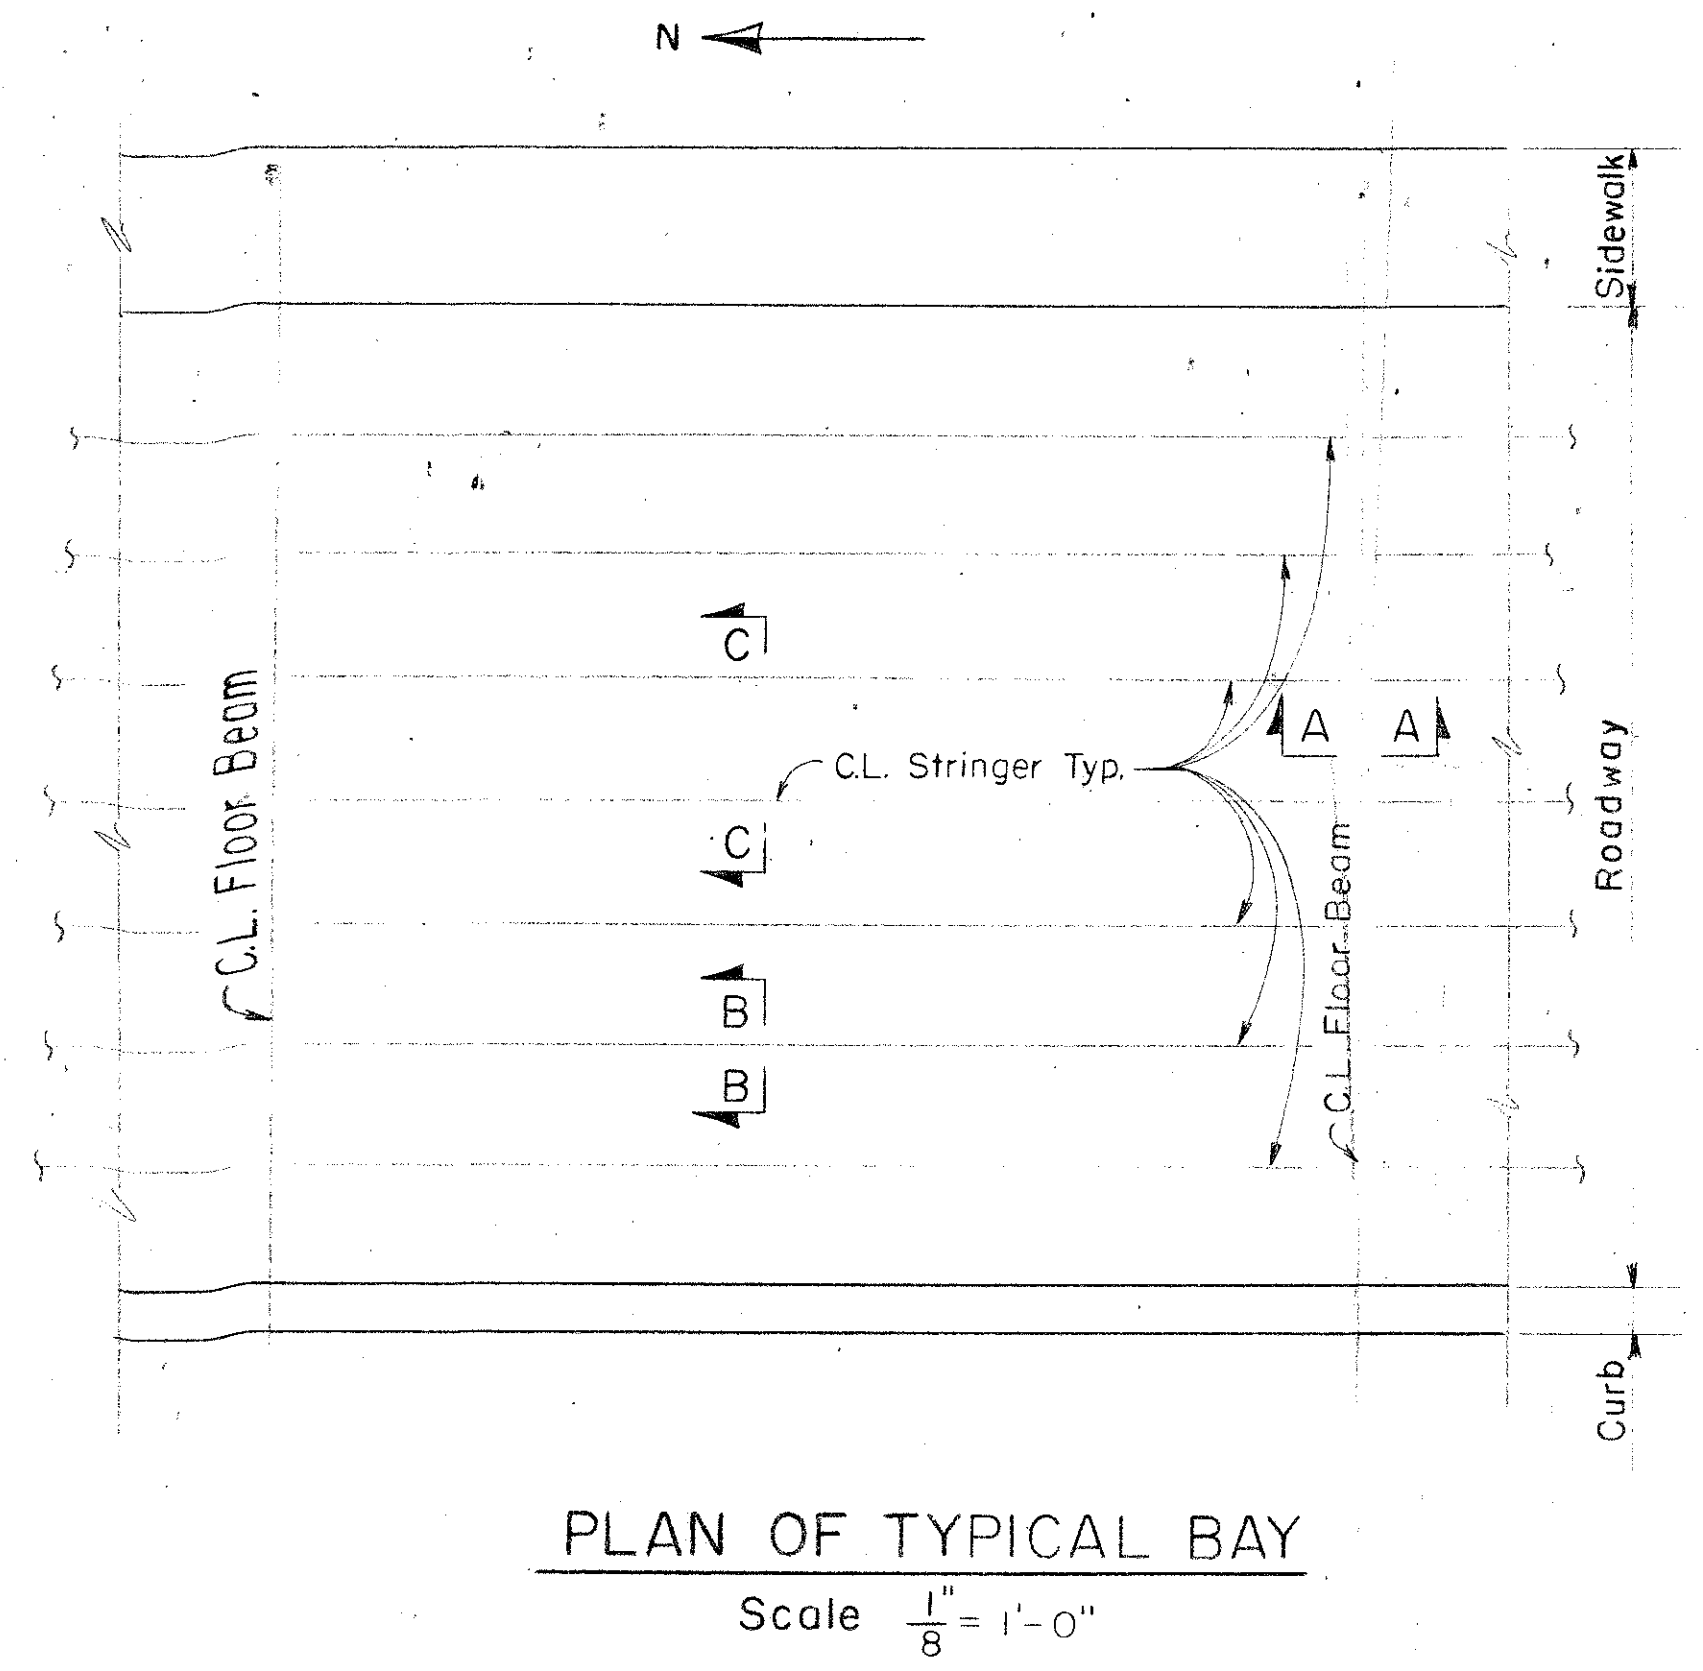
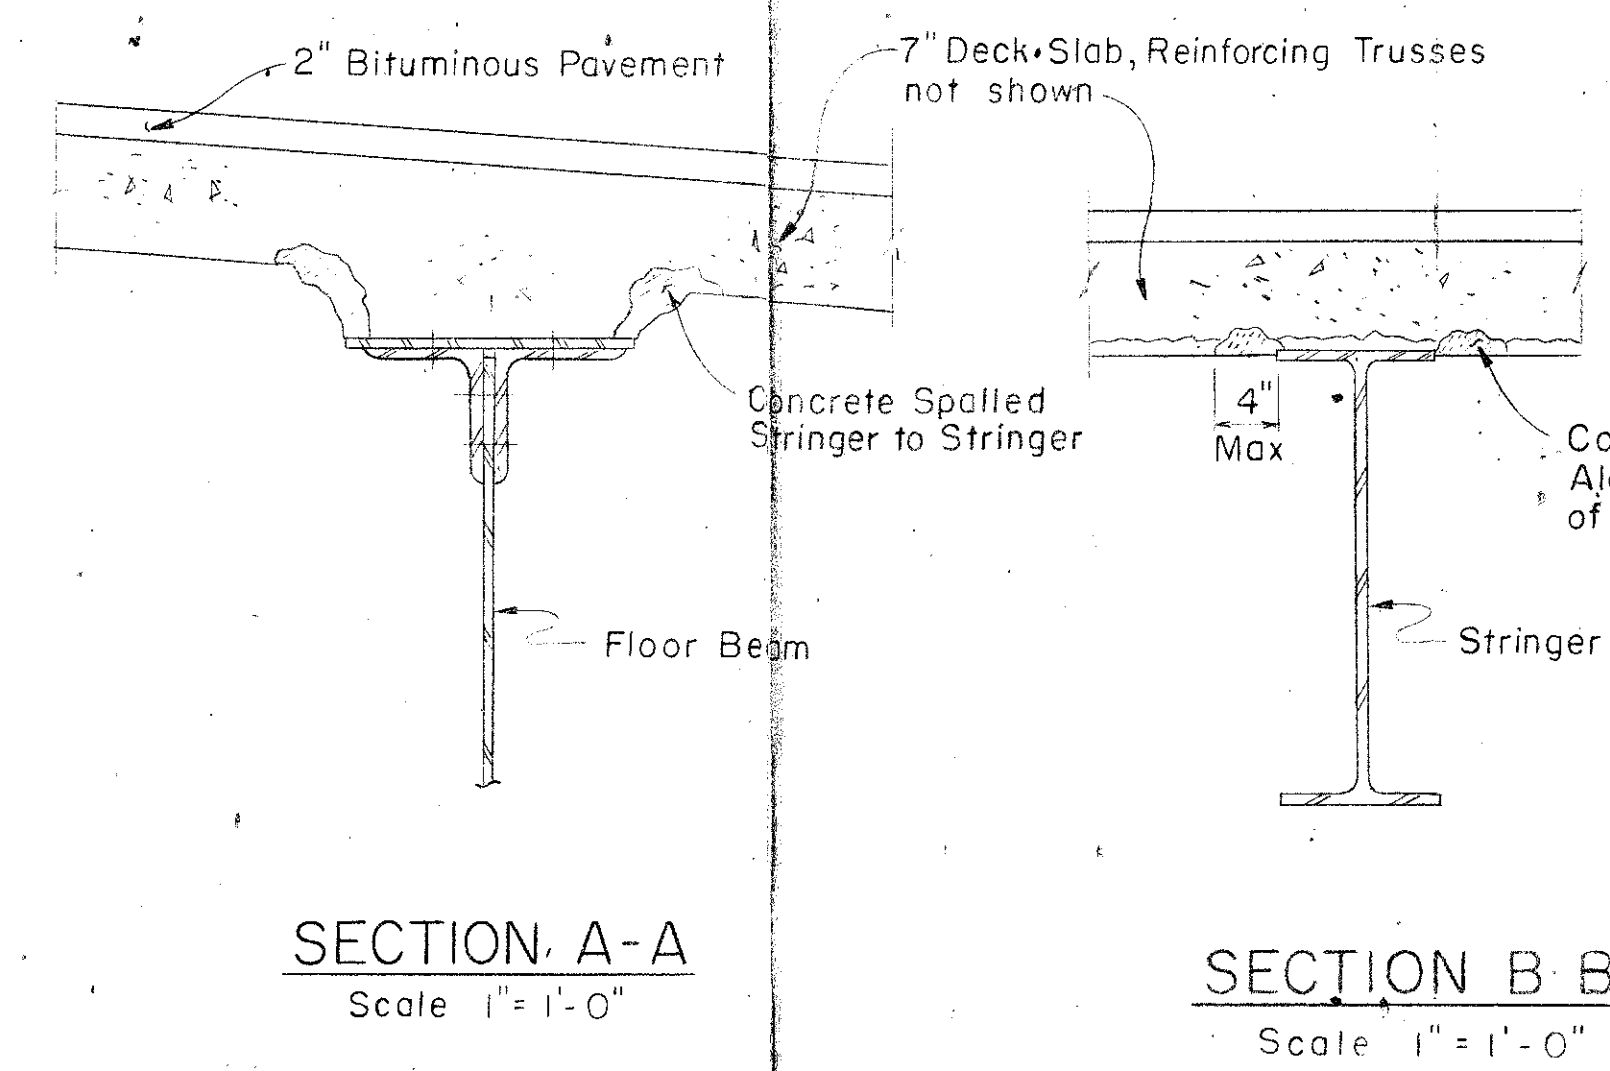
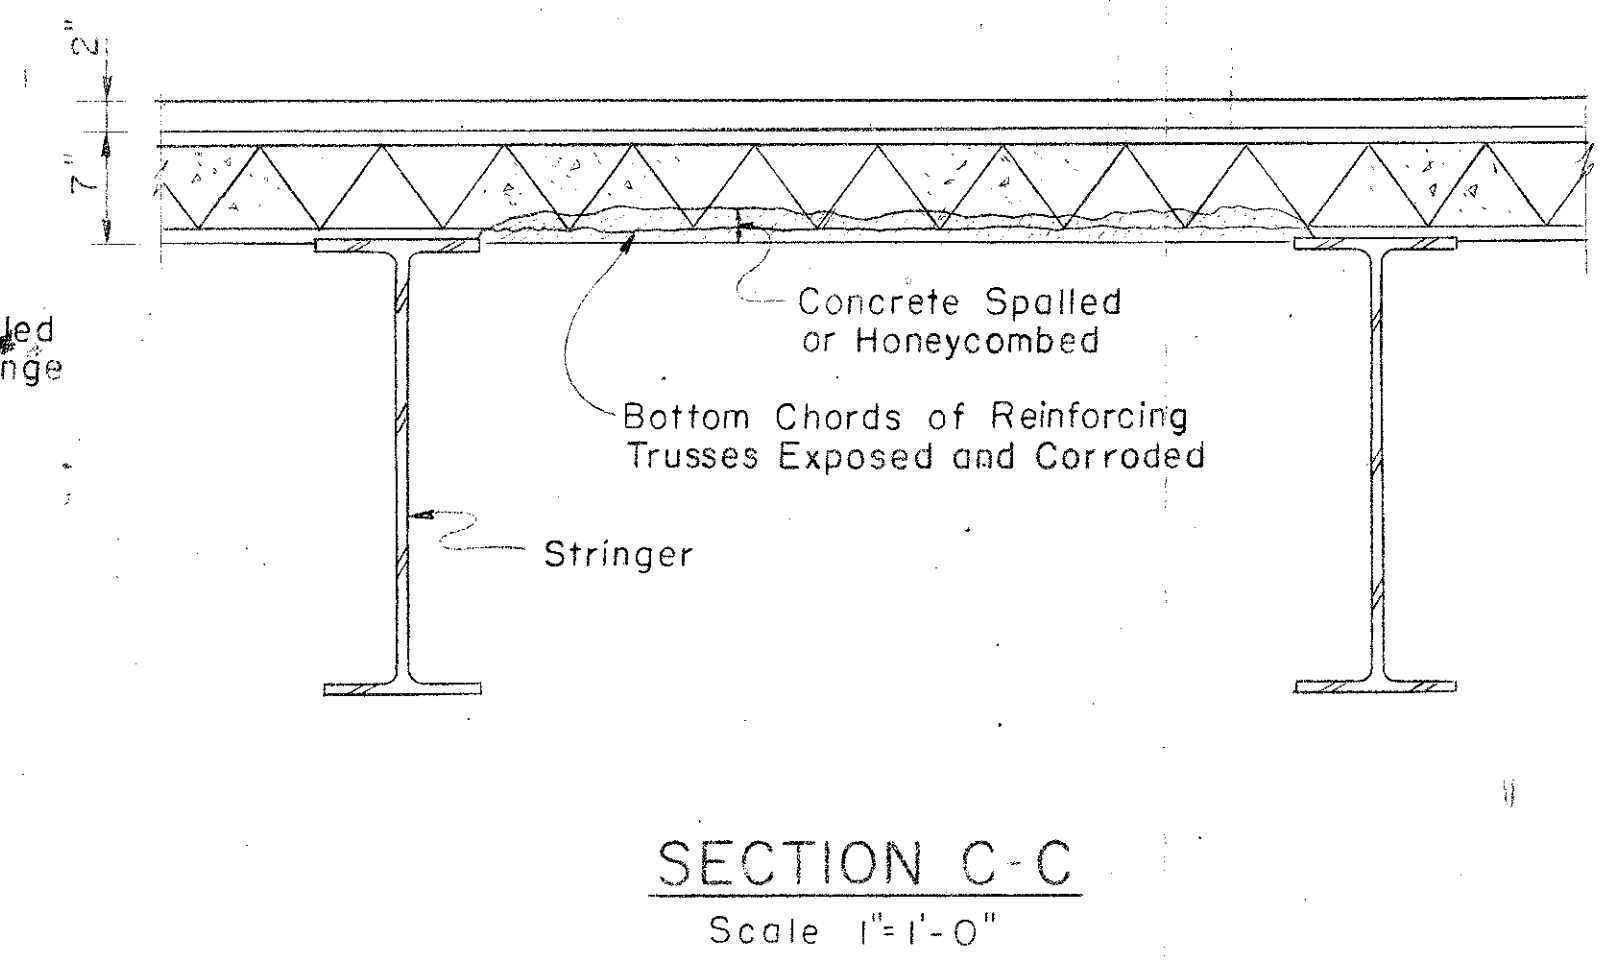
FIG. 8

The general crack pattern at the underside of the deck slab is shown in Figure 8. Section AA indicates concrete spalling along the top flange of the floor beam; Section BB indicates concrete spalling along the top flange of the stringer; and Section CC indicates concrete spalling between stringers, with the lower por-tion of the trussed rebars exposed. The spalling presented in Section CC is the most serious of the three types shown, with res-pect to structural integrity. For this type of spall, with the maximum positive bending moment occurring at the midspan between stringers (compression at the top and tension at the bottom of the slab), the slab cannot act as a reinforced concrete structure since the bottom reinforcing is not bonded in the concrete. Fur-ther, at the stringer flanges where maximum negative moment occurs under wheel loads (tension at top and compression at bottom of the slab), there is no concrete at the slab bottom to resist the com-pression load. However, since trussed rebars were used in the original slab construction (as opposed to the reinforcing bars used today), the wheel loads at these locations are carried by the truss action of these trussed rebars.
